Manhole Inspection Summary

Manhole # S04EE2001MH

Insp Date: **8/9/06 12:00 AM**

Location Address: **3408 FALLSTAFF RD**

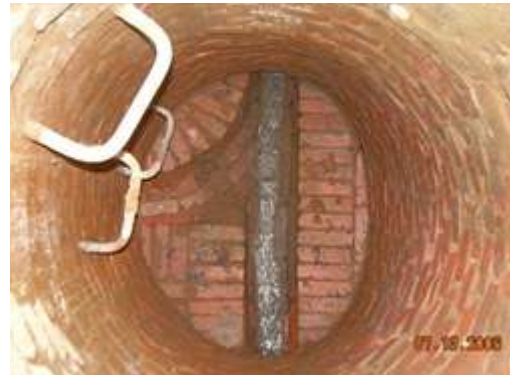
Top View

Adjustment and Barrel infiltration.
Evidence of surcharge - Bench debris.

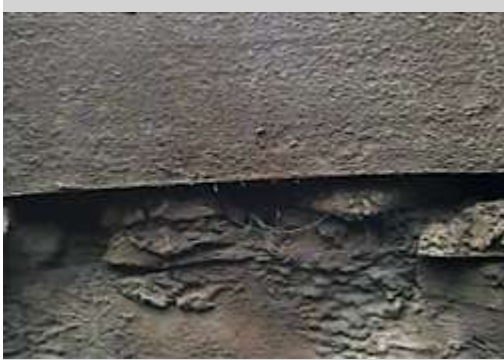
Defect

Frame leaks. Adjustment deterioration
and loose brick. Adjustment infiltration.

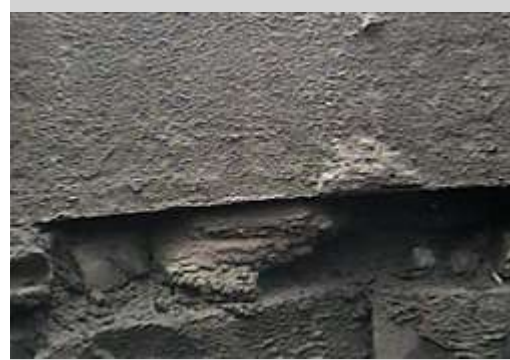
Defect

Frame leaks. Adjustment deterioration
and loose brick. Adjustment infiltration.

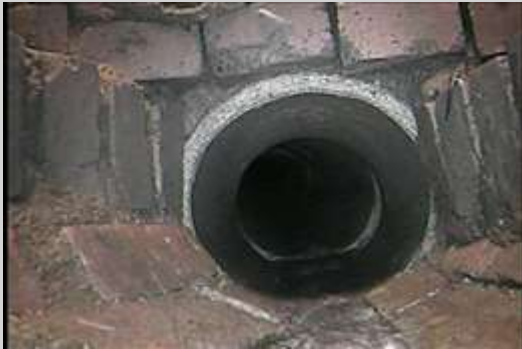
8 in. Circular Gravity Sewer Pipe Out @ 12 O'Clock

Pipe Material: **Clay** ☐ Pipe Lined

Invert Depth: **8.36** (ft.) Flow Characteristics: **Fast**

Deposits: ☒ None ☐ Mud ☐ Sludge ☐ Debris ☐ Grease

Infiltration: **None** Pipe Seal Cond: **Unknown**

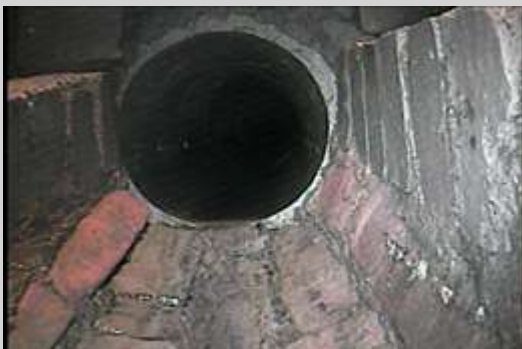
8 in. Circular Gravity Sewer Pipe In @ 6 O'Clock

Pipe Material: **Clay** ☐ Pipe Lined

Invert Depth: **7.82** (ft.) Flow Characteristics: **Fast**

Deposits: ☒ None ☐ Mud ☐ Sludge ☐ Debris ☐ Grease

Infiltration: **None** Pipe Seal Cond: **Unknown**

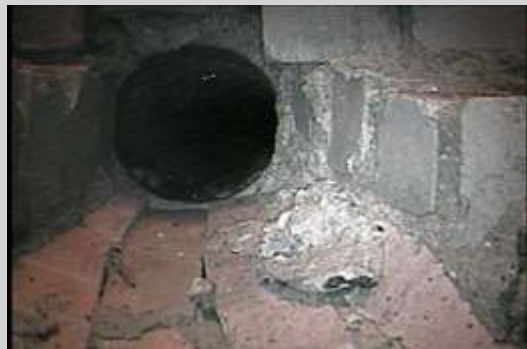
6 in. Circular Gravity Sewer

Pipe Material: **Clay**

Invert Depth: **7.70** (ft.) Flow Characteristics: **None**

Deposits: ☒ None ☐ Mud ☐ Sludge ☐ Debris ☐ Grease

Infiltration: **None**
